SERVICE BULLETIN

Notification Number: **SB-08-04-26-1**

Subject : Continental Motors Rocker Shaft Inspection and Replacement. Reference attached Teledyne Continental Aircraft Engine Service Bulletin # SB08-1.

SUBJECT: ROCKER SHAFT INSPECTION AND REPLACEMENT

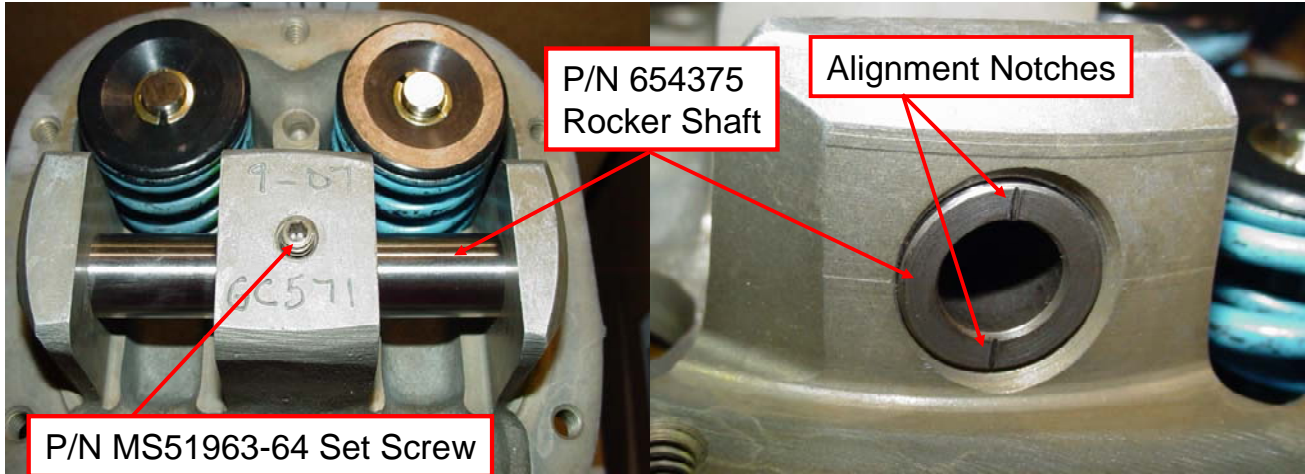
All engines listed above, manufactured after November, 1997 and those which have had cylinders replaced after November, 1997 may utilize the P/N 654375 Rocker Shaft and the P/N MS51963-64 retaining screw. Teledyne Continental Motors (TCM) has received reports from the field of some P/N MS51963-64 Rocker Shaft Retaining Screws losing torque, allowing the P/N 654375 Rocker Shaft to chafe the rocker cover.

FIGURE 1
P/N 654375 ROCKER SHAFT INSTALLATION
(ROCKER ARMS REMOVED FOR CLARITY)

- 4) If the P/N 654375 Rocker Shaft is installed proceed as follows:
 - a) Rotate the engine to bring the piston to top dead center. Both valves will be closed.
 - b) Remove and discard the P/N MS51963-64 Rocker Shaft Retaining screw.
 - c) Remove the P/N 654375 Rocker Shaft and retain for return to TCM.
 - d) Reinstall the rocker arms utilizing a new P/N 21153 Rocker Shaft.

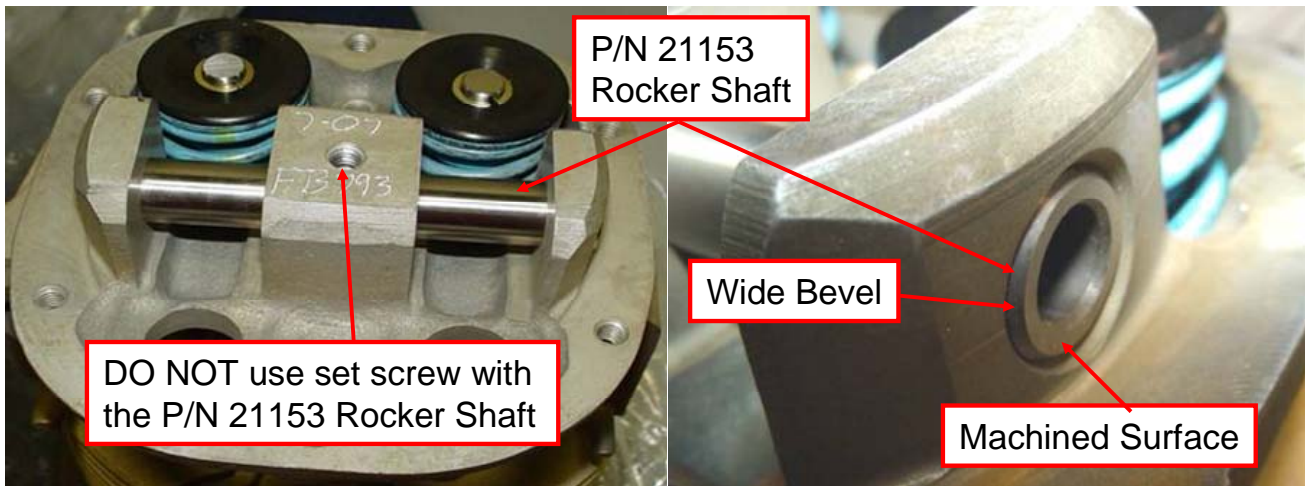
FIGURE 2
P/N 21153 ROCKER SHAFT INSTALLATION
(ROCKER ARMS REMOVED FOR ILLUSTRATION)

The P/N MS51963-64 Rocker Shaft Set Screw MUST NOT be used with the P/N 21153 Rocker Shaft.

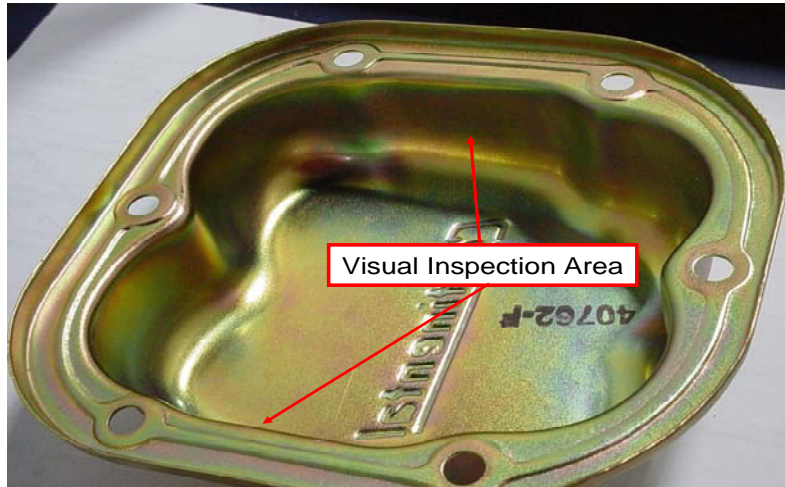
- 5) If the P/N 654375 Rocker Shaft was installed, inspect each Rocker Cover for chafing in the areas as indicated in Figure 3. If damage in the form of metal removal is found, the Rocker Cover must be replaced with a new P/N 40762 Rocker Cover. Acceptable wear pattern is shown in Figure 4.

**FIGURE 3
ROCKER COVER INSPECTION**

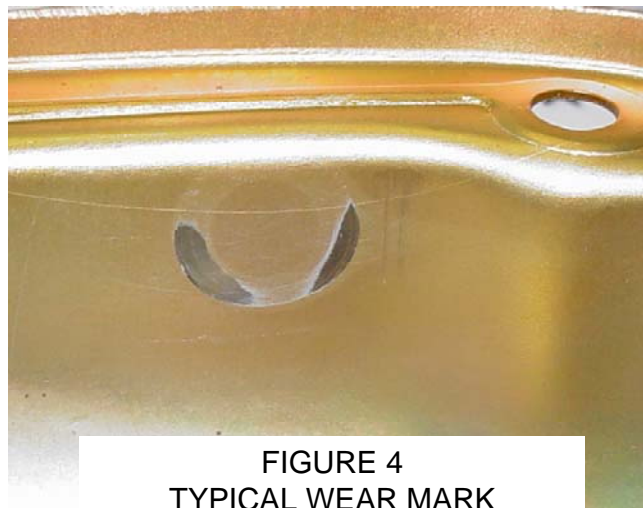
**FIGURE 4
TYPICAL WEAR MARK
FLOATING ROCKER ARM SHAFT**

NOTE: A wear mark on the Rocker Cover is normal when utilizing a floating Rocker Shaft such as the P/N 21153 and is not an indicator for Rocker Cover replacement.
