SERVICE BULLETIN

Notification Number	SB-08-12-01-1
Subject	Sensenich Ground Adjustable Propeller Service Memo #C08-1A
Supersedes Notices	SB-08-11-19-01
Release Date	December 1, 2008
Effective Date	December 1, 2008
Required Corrective Action	Compliance with Manufacturer Service Memo
Affected Make	American Legend Aircraft
Affected Models	AL3, AL11 (Continental O-200 Powered)
Affected Serial Numbers	AL-1041, AL-1128, AL-1133, AL-1135, AL-1140, AL-1142. Any others with affected propeller installed.

Service Memo C08-1A

Hub clamp bolt replacement for the Continental 0-200 Composite propeller retention system. Lowering the time between clamp bolt replacements to **10 hours**.

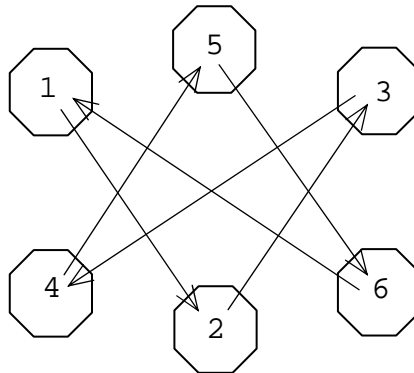
Recent incidents of hub clamp bolt failures used to secure the propeller hub halves have prompted Sensenich Propeller Mfg. Company Inc. to issue a service memo to replace and torque to 28-30 Ft-lb. the (6)-AN6-15A clamp bolts every **10 hours** of operation. Please call (717-569-0435) or email (sales@sensenich.com) the Sensenich Propeller Mfg. Company Inc. for replacement bolts at no cost.

Using a calibrated torque wrench and following the pattern shown below. Tighten the bolts in $\frac{1}{4}$ to $\frac{1}{2}$ turn increments (this will take several passes) until the proper torque given in **Table 1** is reached. It is important to maintain an even gap between the hub halves.
