## SERVICE BULLETIN

<b>Notification Number</b>	<b>SB-10-08-09</b>
<b>Subject</b>	<b>TCM Special Service Instruction SSI10-5</b>
<b>Supersedes Notices</b>	<b>None</b>
<b>Release Date</b>	<b>August 9, 2010</b>
<b>Effective Date</b>	<b>August 9, 2010</b>
<b>Required Corrective Action</b>	<b>Immediate compliance with TCM Special Service Instruction</b>
<b>Affected Make</b>	<b>American Legend Aircraft</b>
<b>Affected Models</b>	<b>AL3, AL11</b>
<b>Affected Serial Numbers</b>	<b>AL-1051, AL-1147, AL-1150, AL-1151, AL-1153 through AL-1157</b>

**SSI10-5**

**SUBJECT:** Part 1; Sump inspection and Oil Gage Rod replacement O200D1B S/N as listed.  
Part 2; Inspection for machining material, all O200D1B and D2B

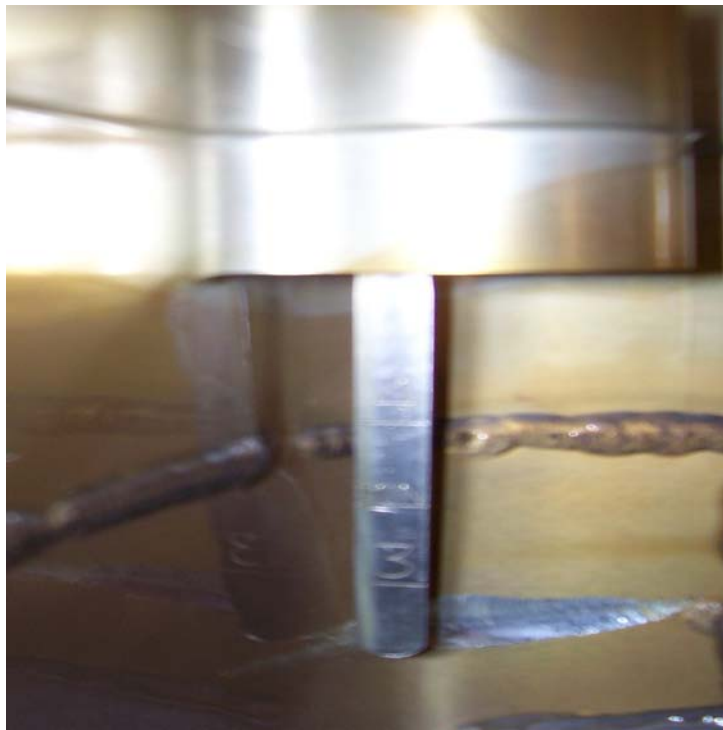
TCM has been notified of certain engines in which the Oil Gage Rod (Dipstick) is chafing the inside of the oil sump directly below the oil filler housing. This chafing of the oil gage rod can cause metal shavings to be displaced from the sump wall. The shavings may be visible in the oil filter assembly and/or drain oil.

The engine serial numbers listed above and any other operational (flying) O200D1B engines must have the oil sump removed and the left sump wall inspected directly below the oil filler/oil gage rod housing. Inspect the sump wall for chafing or any indication of contact of oil gage rod to sump.

Drain the oil sump, remove sump from the bottom of the crankcase. Inspect the left wall of the oil sump directly below the lower termination of the oil filler/oil gage rod housing. A mirror/light combination or borescope may be used in this inspection.

Inspected engines may continue in use, pending a replacement of the oil gage rod. The original oil gage rod, part number 657474-1, is to be temporarily replaced with a modified oil gage rod part number 657474-1-M. This oil gage rod (plug) is shortened and cannot contact the oil sump.

**The original oil gage rod must be removed and kept stored in the aircraft in a suitable protective container to allow access for use during preflight or post flight inspections and oil level servicing until a replacement oil gage rod is installed.**

After each preflight, post flight or oil level check, the original oil gage rod is to be removed from the engine and returned to its suitable protective container in the aircraft prior to starting the engine. The modified oil gage rod (plug) must be installed for all ground and flight operation of the engine.
