SERVICE *No.* 207A BULLETIN

SUBJECT: Inspection of Weld at Rudder Pedal Assembly
(Part Nos. 40842-04 and 40842-05)

MODELS AFFECTED: PA-18 and PA-18A Super Cub - Serial Nos. 18-1 thru 18-7768
inclusive

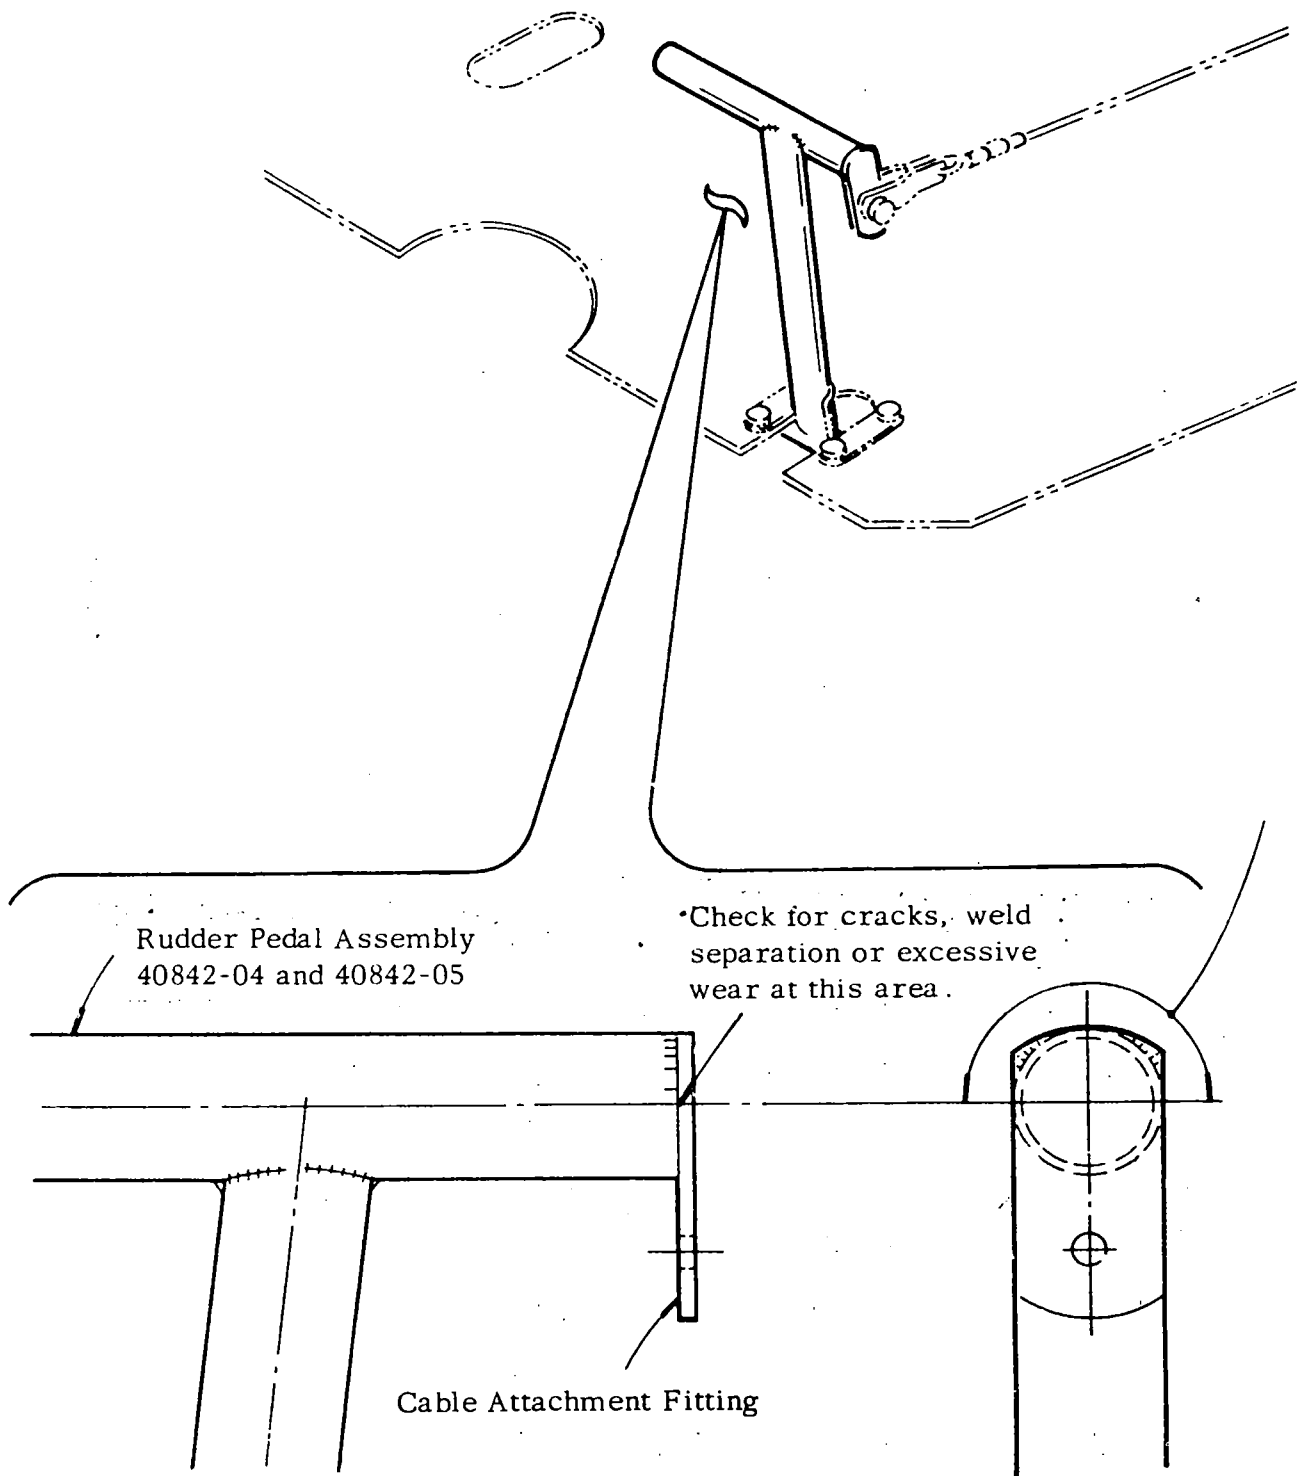
Rudder Pedal Assembly
40842-04 and 40842-05

Field service reports indicate that there have been a few instances of weld separation where the rudder pedal cable attachment fitting is welded to the rudder pedal.

•Check for cracks, weld
separation or excessive
wear at this area.

Any cracks in weld, regardless of length of weld or location of crack, shall be cause for rejection of rudder pedal assembly.

If there is evidence of weld separation, cracks, excessive wear, or the length of the weld does not conform to the dimensions referred to on the sketch; the rudder pedal must be replaced prior to further flight.
