Pre-flight inspection on main wheel RF-024

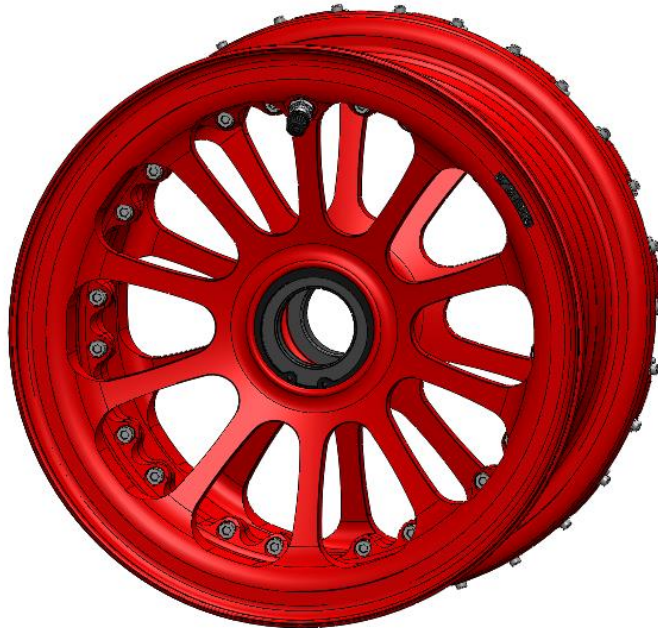
This Service Bulletin is issued to alert operators and pilots to monitor the condition of the main wheel rims RF-024 during preflight inspection; to ensure continued airworthiness and prevent potential wheel material crack.

1. Visually inspect both main wheel rims for any signs of cracks.
2. Pay particular attention to the spokes area.
